#### **Agenda**

#### West Lake Landfill

## 2008 WLL ROD Conceptual Design

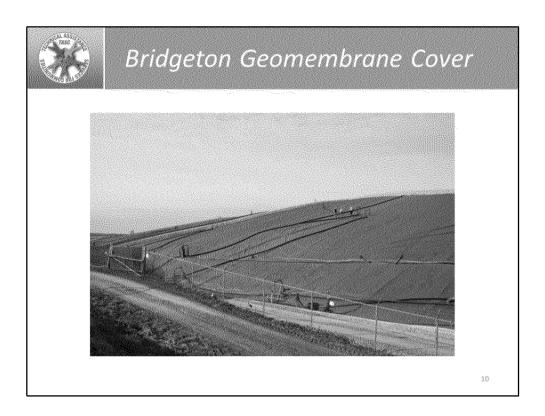
#### **Bridgeton Geomembrane Cover**

According to EPA's Bridgeton Landfill website, all 42 acres of the South Quarry at the Bridgeton Landfill have been covered with a three-layer geomembrane (plastic) liner to capture odor and facilitate landfill gas collection. As shown, the liner has been placed on top of whatever soil/clay covering or cap already existed on the South Quarry.

I don't have specific information about the Bridgeton Landfill cap under thegeomembrane shown on this slide. The next slide provides some information about typical nonhazardous and hazardous landfill caps.
